# CHULA VISTA FIRE DEPARTMENT

# GREEN SHEET

## Informational Summary Report of Serious CVFD Injuries, Illnesses, Accidents, and Near Serious Accidents

### Action Footwear Commercial Structure Fire and Serious Burn Injuries January 25, 2021

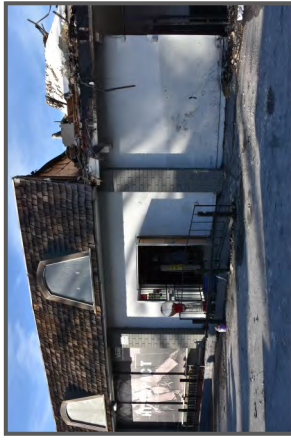
D Side Double Doors

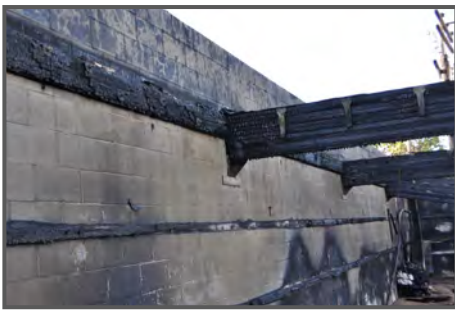
CMU

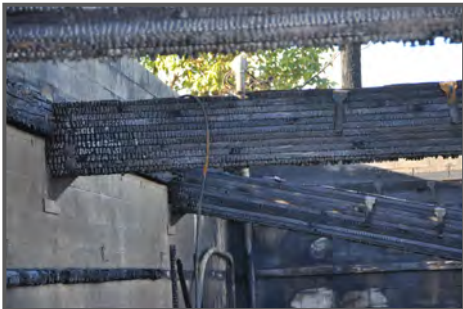
Beams

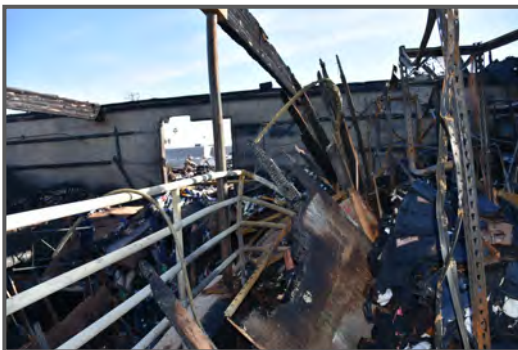
Middle Landing towards D

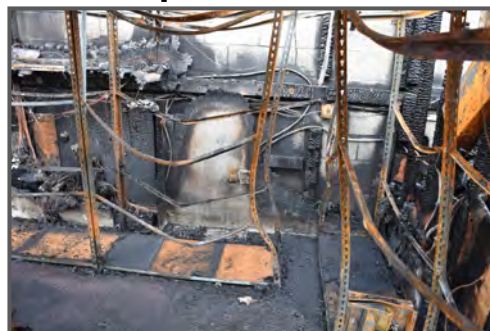
Metal Storage Racks

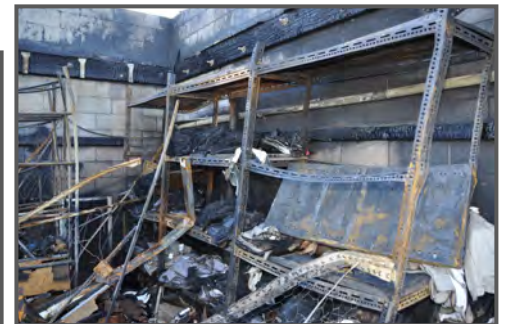
Metal Racks and CMU

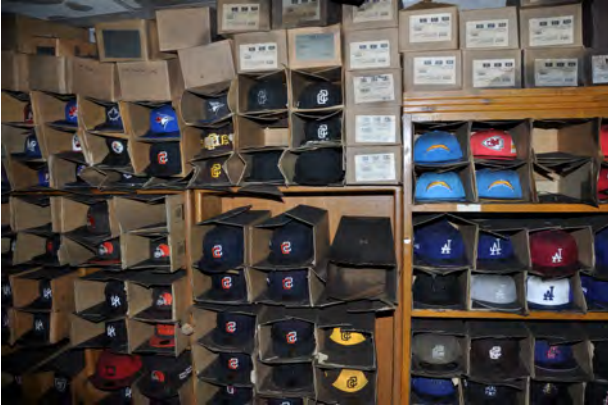
2nd Floor near center of bldg. looking towards D

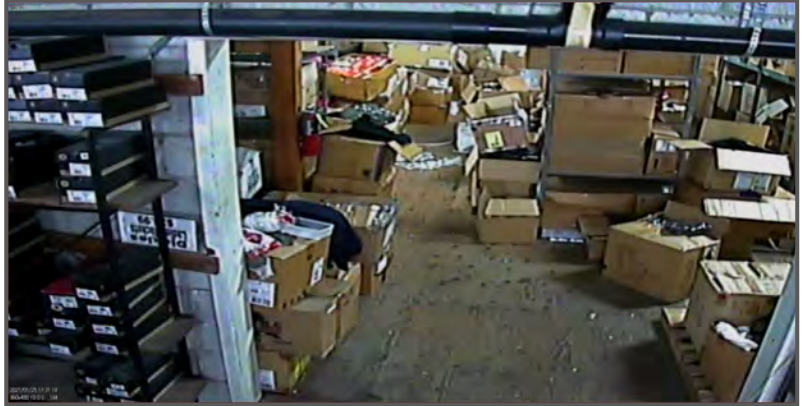
2nd floor looking towards C

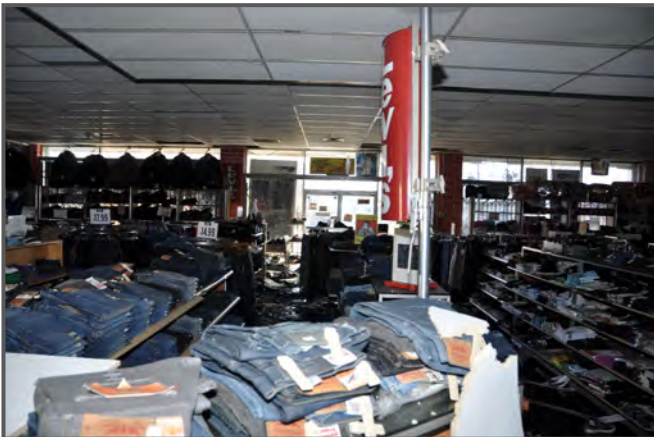
Showroom middle D doors looking towards A Double doors

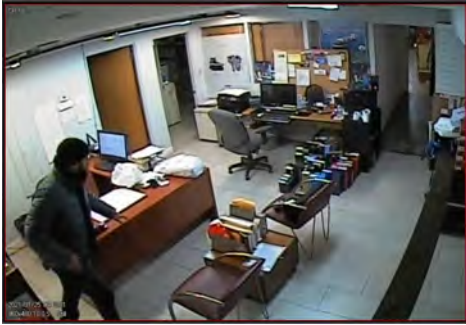
Employee runs downstairs 1740

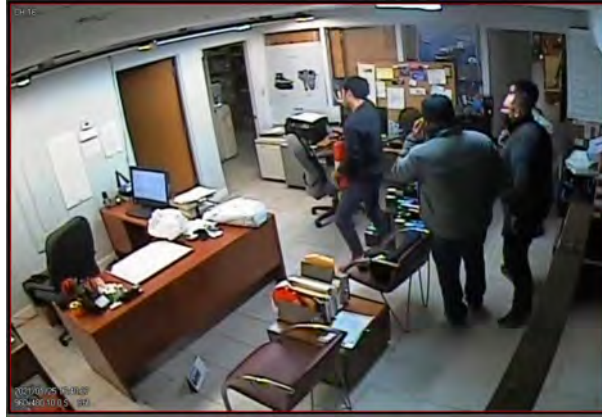
Employee with first fire extinguisher

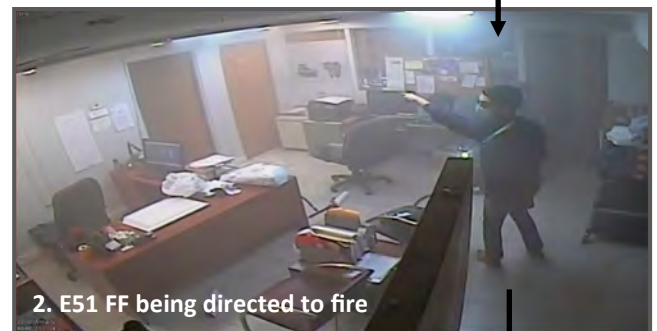
2. E51 FF being directed to fire

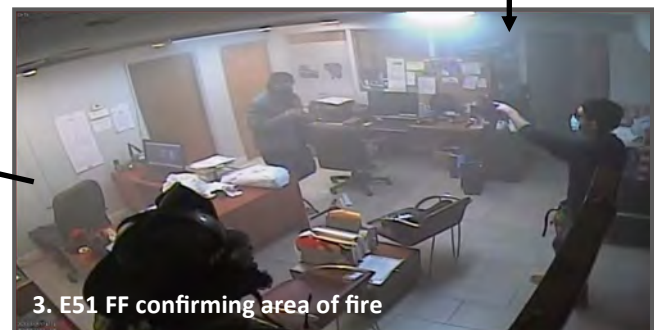
3. E51 FF confirming area of fire

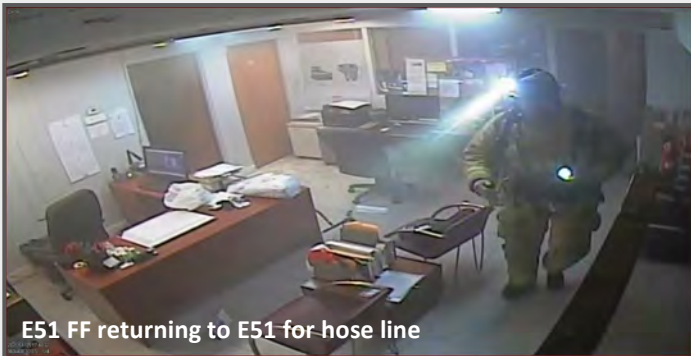
<p>E51 FF returning to E51 for hose line</p>

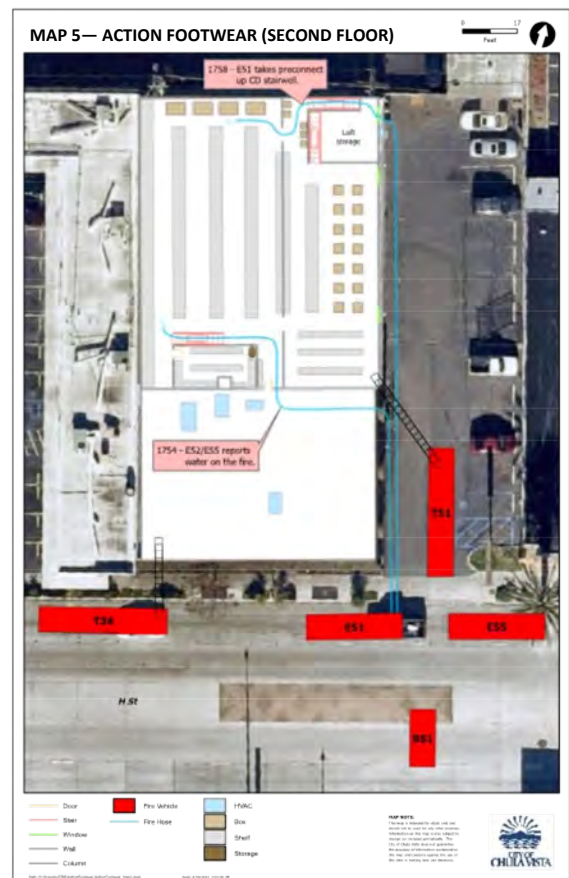
Full size image located in Appendix A.5

Time	Units	Event Details
17:55	E30	RIC places ground ladder raised to D side window above south end of car port
	B51	IC/B51 advises FA/E51 that he will now be Division C to "clean this up", understands he is on C/D corner with E55. E52 will remain Div A
	E51	E51 CA understands the transition to the two divisions and it is cleared up before they ascend with the hose line
	T51	<ul style="list-style-type: none"> <li>T51 EN advises T51 CA that aerial ladder is in place on A/D corner of 2<sup>nd</sup> story portion, asks if he should report to roof. T51 states "affirmative"</li> <li>T51 EN reports wind has subsided when he reached top of aerial ladder and he can see entire roof and crew</li> <li>T51 FF performs inspection cut on east roof (white roof), observes little smoke, and identifies rafter direction (N-S or A-C) and roof as panelized</li> </ul>

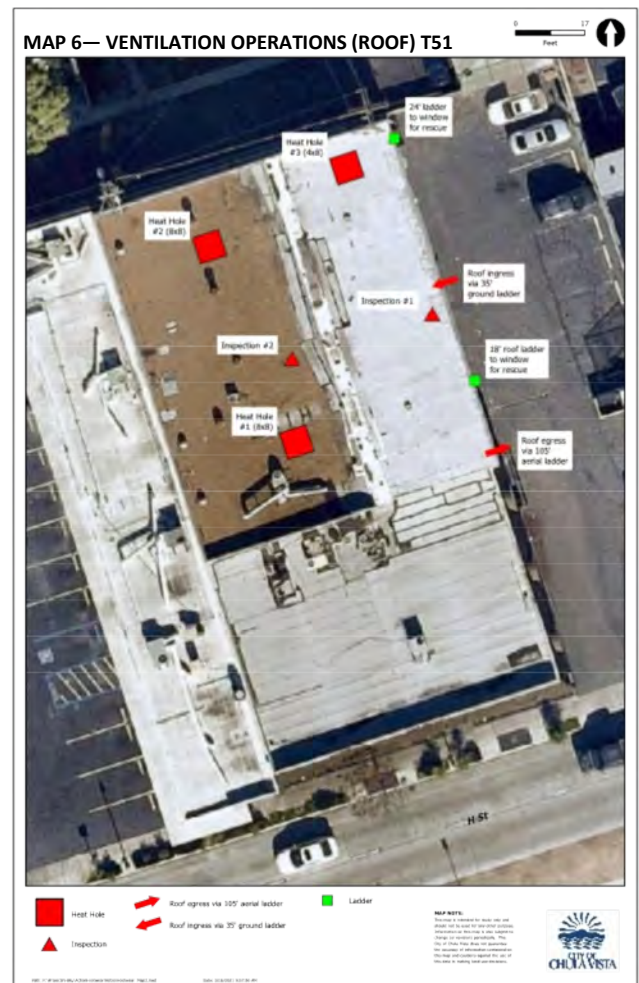
Full size image located in Appendix A.6

18:04	T51	Vent/T51 repeats first offensive heat hole cut with heavy fire in the attic, A/B corner unstable with heavy loads above them (E52), continuing to work in stable C/D corner. IC copies, reminds Vent to exit roof if needed
	T34	T34 hails Vent/T51, no response
